Yfirborðsmerkingar

Ending og efnisnotkun

Guðbjörg Lilja Erlendsdóttir
Arna Kristjánsdóttir
Verkfræðingar, Umferðar-
og skipulagssvið

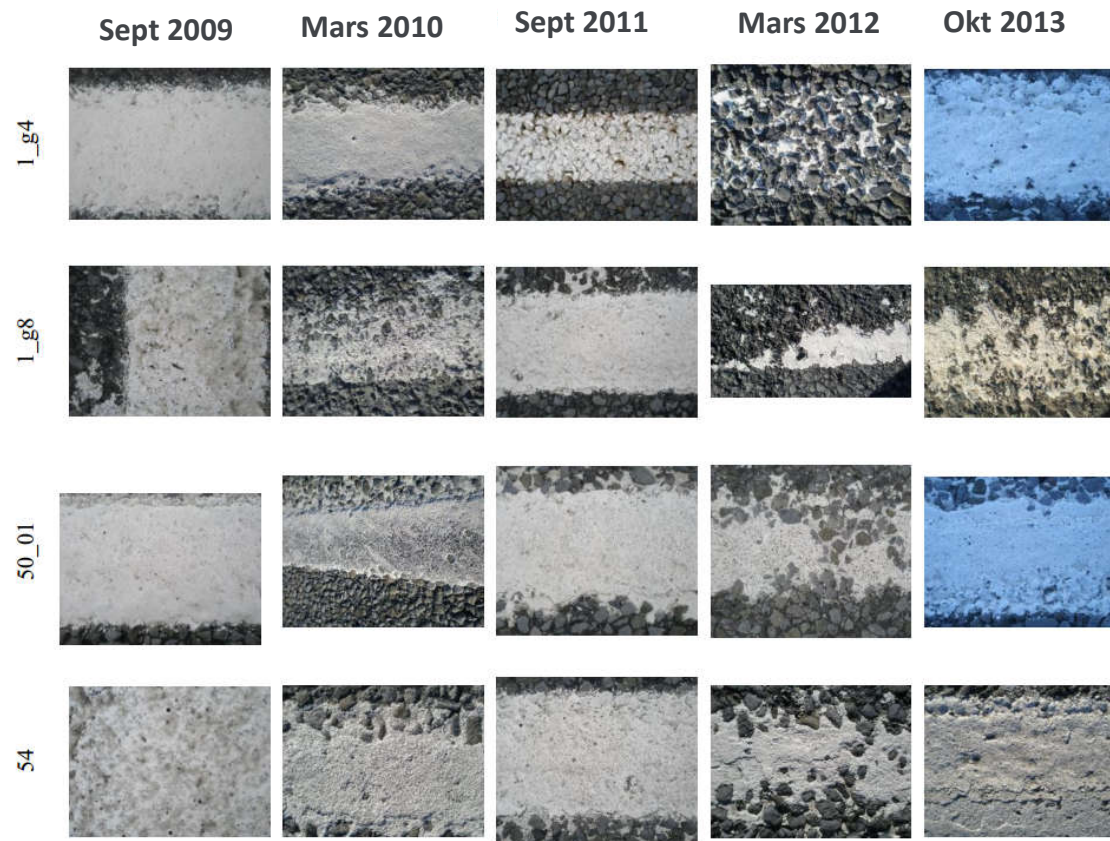
Prófun á endurskini

- Mælingar á endurskini vegmerkinga fyrir 4 vegkafla á árunum 2009 - 2014

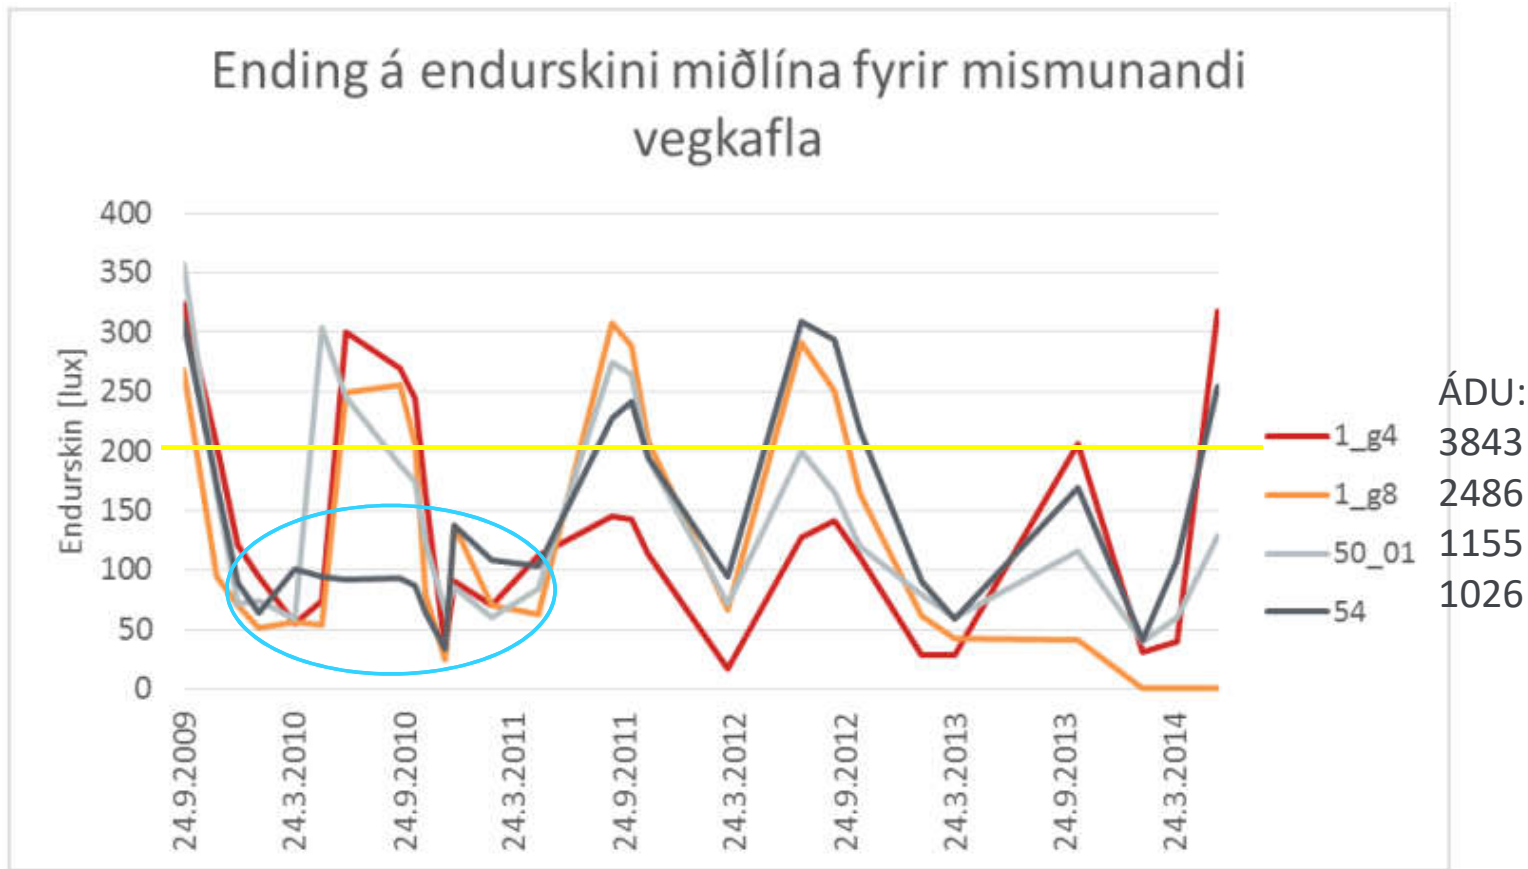
Prófun á endurskini- Ending

* Endurskin vegmerkinga á vegum utan þéttbýlis: 200 lux

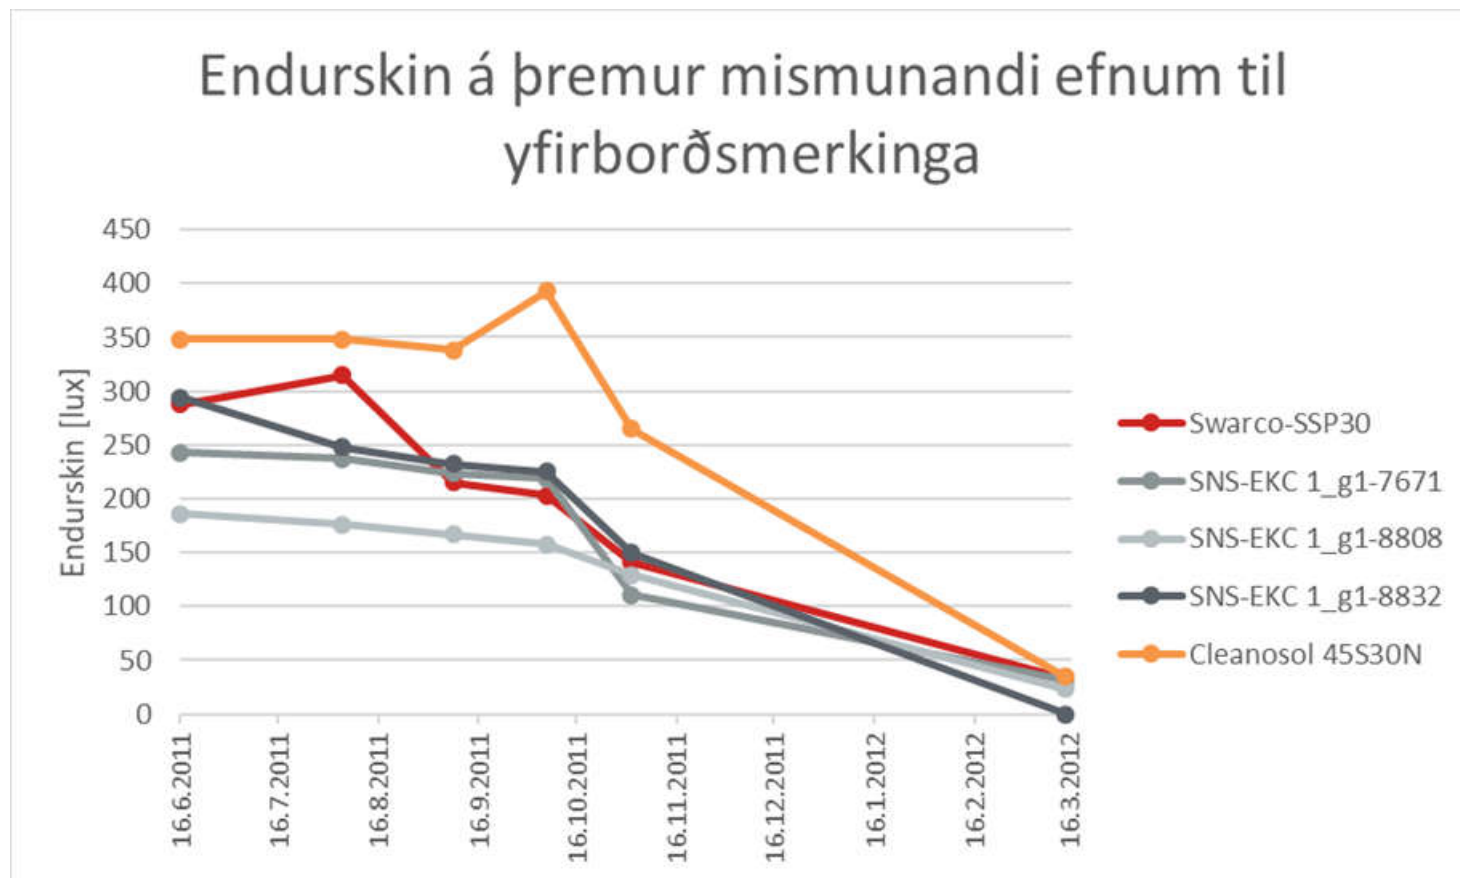
Prófun á mismunandi efnum frh.

- 3 mismunandi efni prófuð á einn vegkafla milli Borgarness og Hvalfjarðarganga
 - Swarco-SSP30
 - SNS-EKC (3 mælipunktur)
 - Cleanosol-45S30N
